CIRCULAR LETTER NUMBER 28-2007

ROTAX
NEW AGE KARTING

SHIFT CONTACT ADJUSTMENT

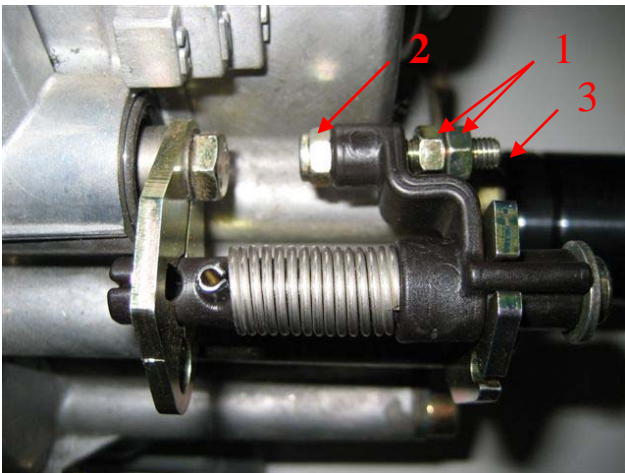
In the past we had some problems with wrong adjustments of the shift contact what caused shift contact 660531 breakings. To avoid assembly mistakes we introduce now to you the new adjustment procedure.

- ⇒ Loosen the (1) two hex nuts 242071 and the (2) lock nut 842030.
- ⇒ Turn the (3) adjustment screw 440781 into the (2) lock nut 842030 until it aligns.

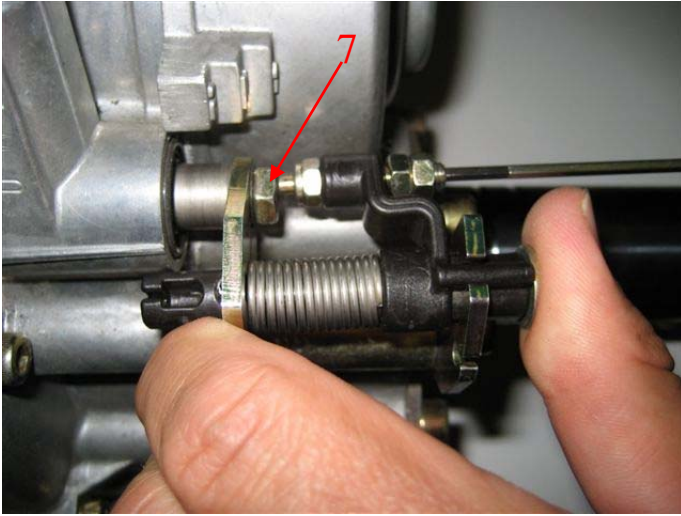
Note: Verify that you don't overturn the (3) adjustment screw 440781 to avoid breaking of the (5) shift contact arm.

⇒ Turn the (3) adjustment screw 440781 in until it stops on the (7) hex screw 240381.

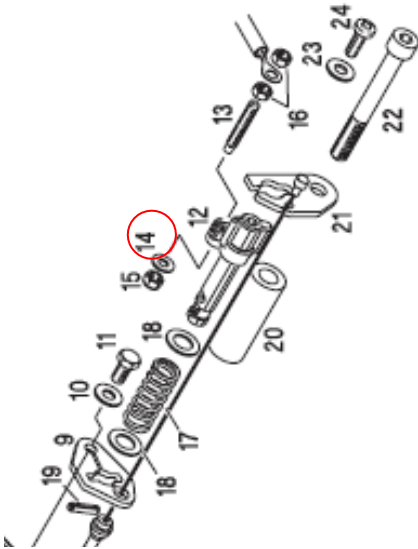
The reason for removing the washer is that the (13) adjustment screw 440781 get completely tighten throw the whole length of the (15) lock nut 842030.

The (14) washer 927571 is not any more implemented in the shift contact system on the 125 MAX DD2 engine.
